VPDES PERMIT PROGRAM FACT SHEET

1. PERMIT NO.: **VA0087599** EXPIRATION DATE: **11/30/2008**
2. FACILITY NAME / MAILING ADDRESS FACILITY LOCATION ADDRESS (IF DIFFERENT)

Associated Naval Architects, Inc.
3400 Shipwright Street
Portsmouth, VA 23703

COMMONWEALTH OF VIRGINIA
DEPARTMENT OF ENVIRONMENTAL QUALITY
TIDEWATER REGIONAL OFFICE
5636 SOUTHERN BOULEVARD
VIRGINIA BEACH, VIRGINIA 23462
RECONNAISSANCE INSPECTION REPORT

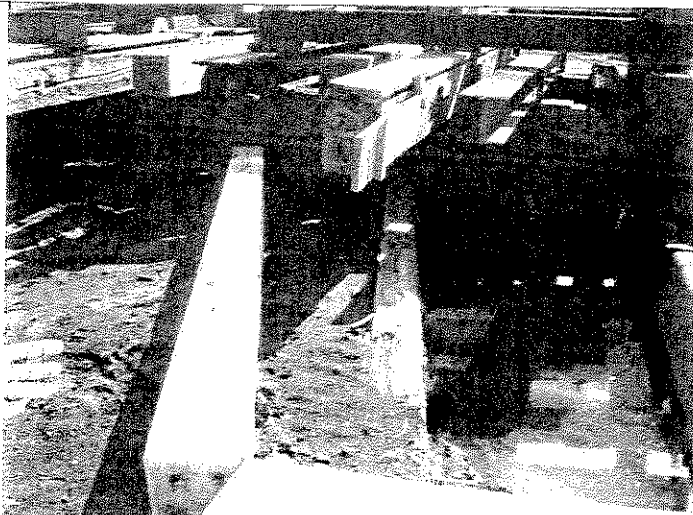
Photo 1. Concrete blocks at the west side of Railway #4.

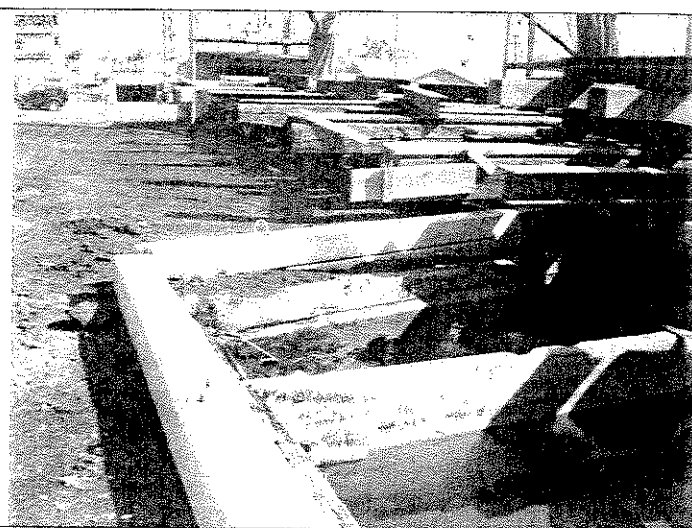
Photo 2. Another view of Railway #4.

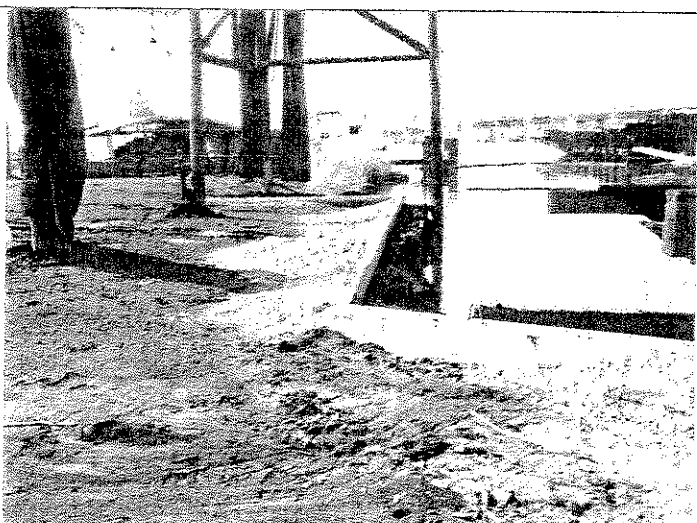
Photo 3. East side of Railway #4.

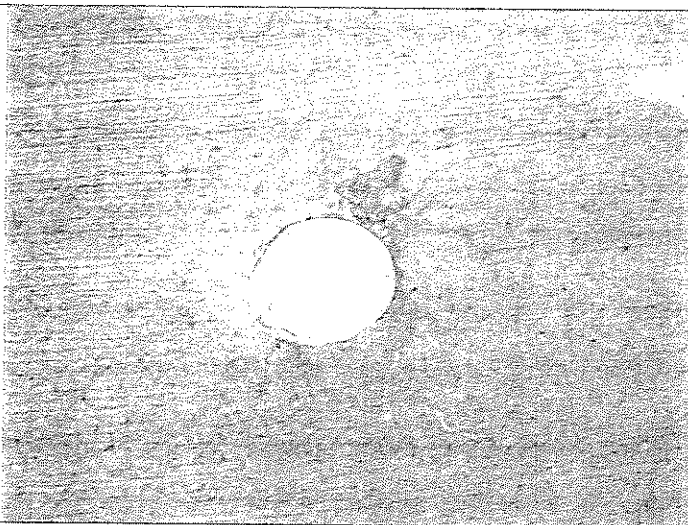
Photo 4. Clean filter material in scuppers of the outfitting pier.

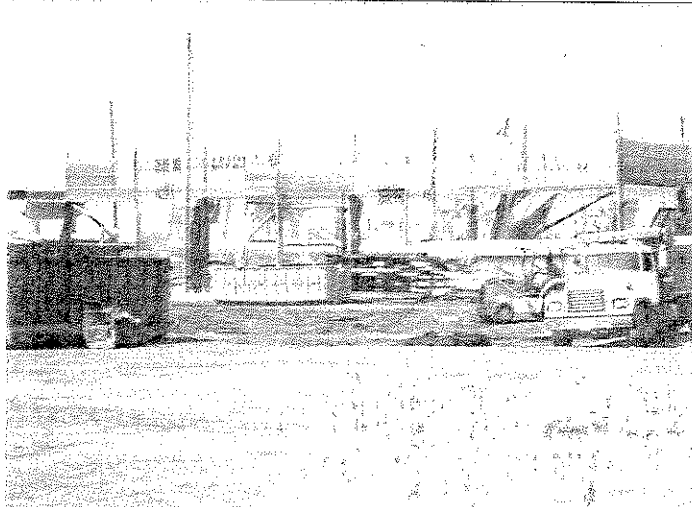
Photo 6. Clean-up and grading around the central drop inlet on site.

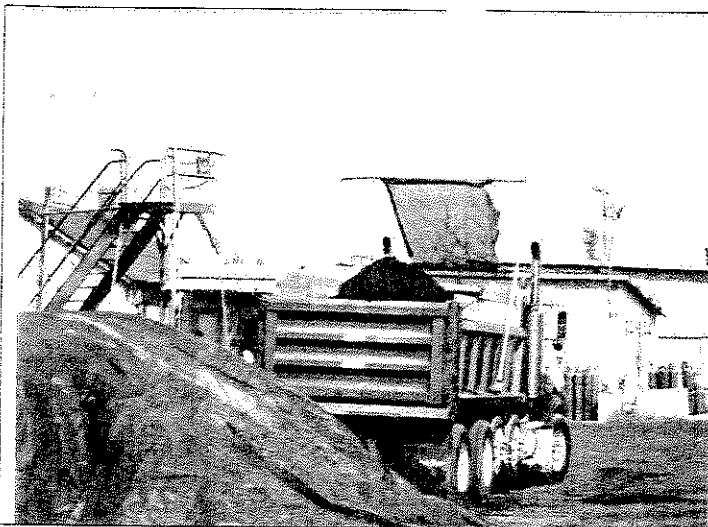
Photo 7. A truck loaded with blast grit leaving facility.

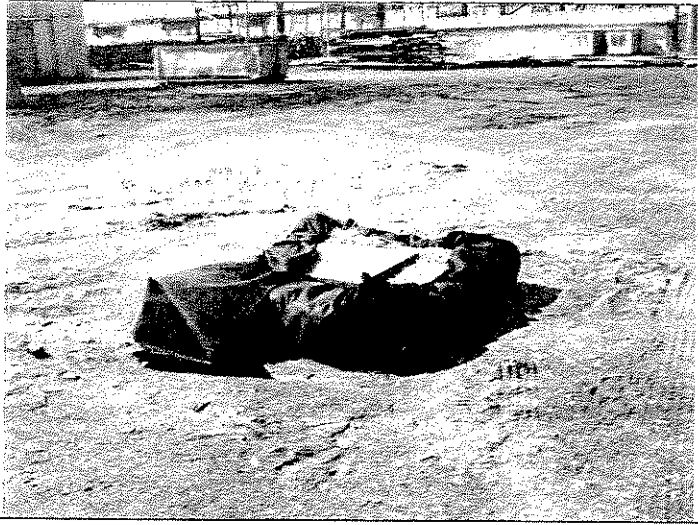
Photo 13. Drop inlet in center of facility.

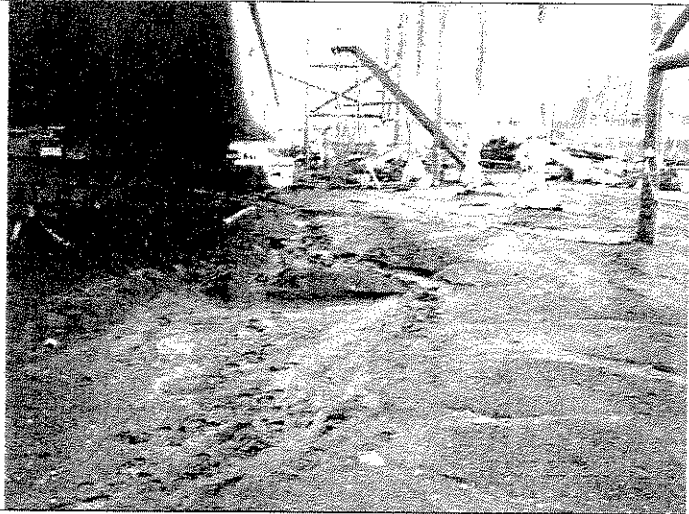
Erosion pattern on western side of railway #4.

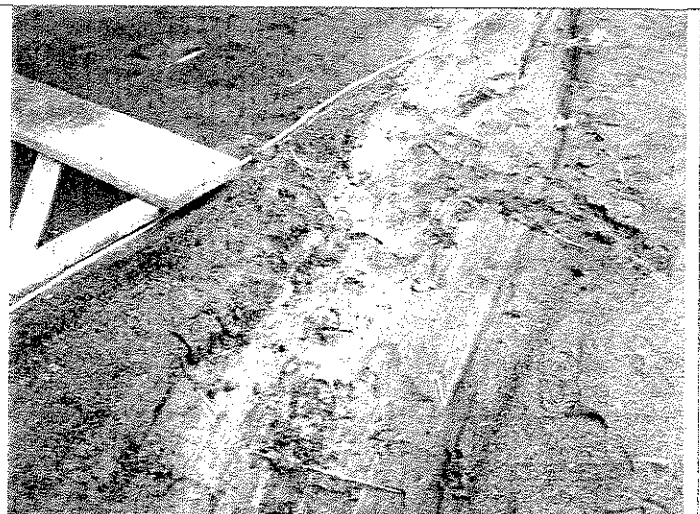
Trash and debris observed at railway #4 including several welding rods.

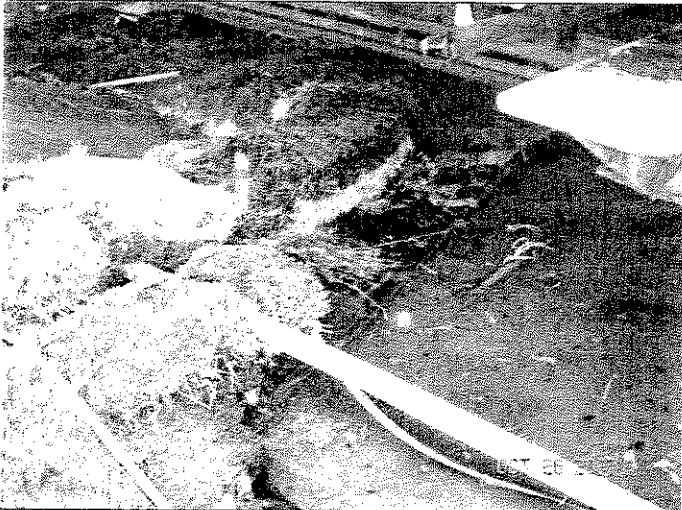
End of railway with hay bales in place. Some blast materials is making it through this since it has not been well maintained.

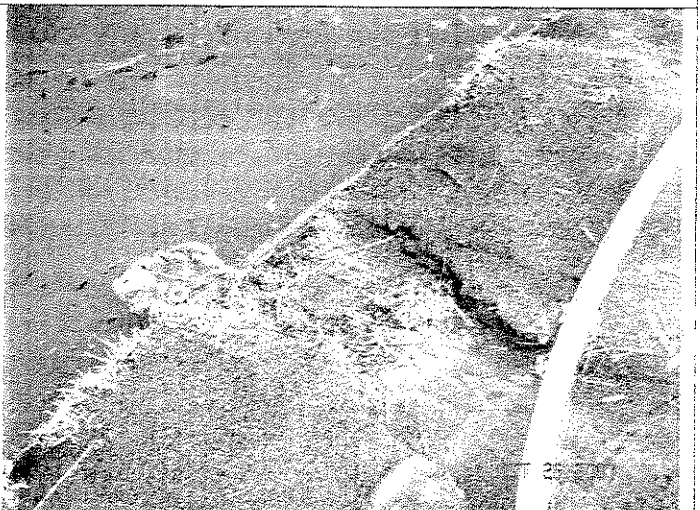
Erosion pattern at the waterfront bulkhead at railway #4. This situation has not changed since September.

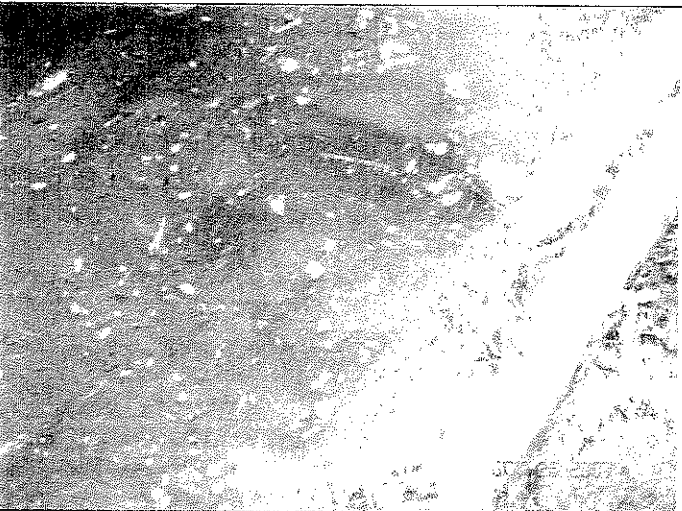
Sandblast grit in the water.

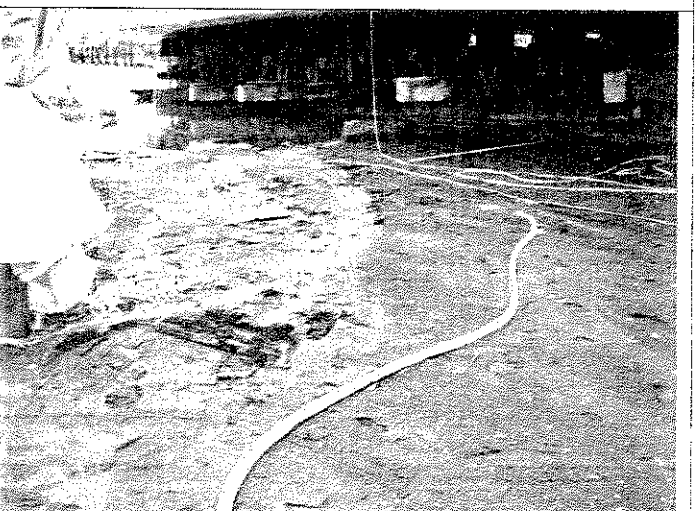
Erosion pattern for the eastern side of the railway #4.

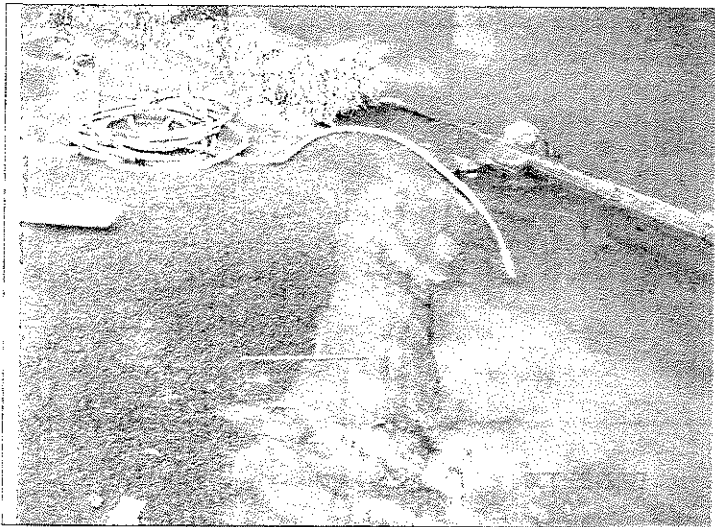
Blast materials, covered hay bales and welding rods at railway #4.

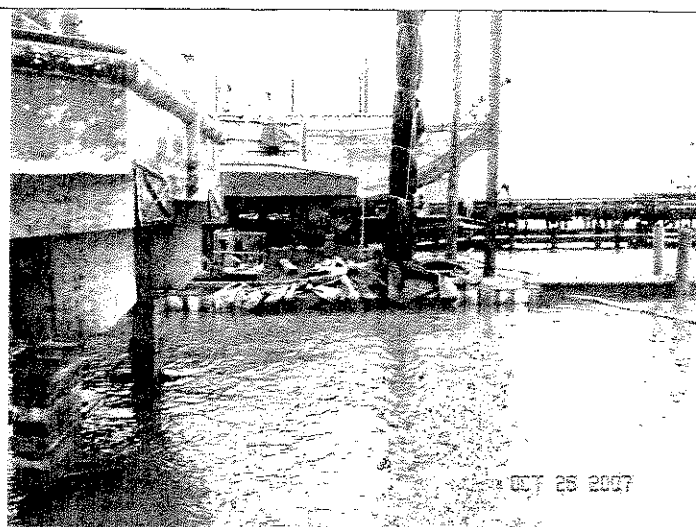
View looking to the east with railways #3 in the foreground, #2 in the middle and #1 in the background. All of these vessels are overhanging the water.

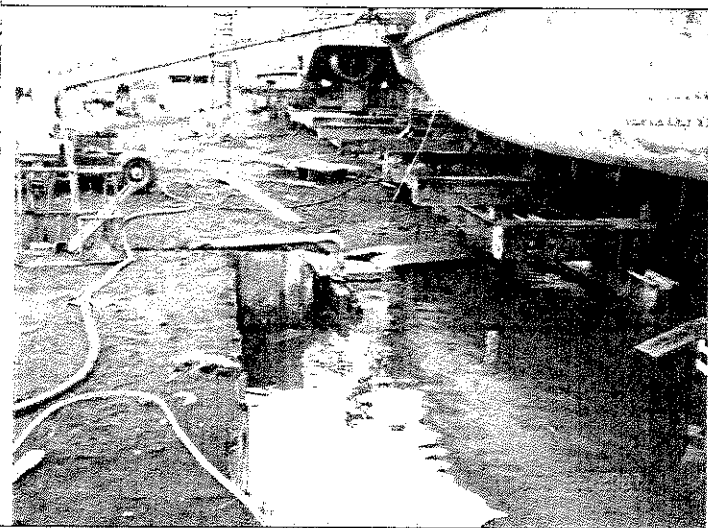
View of railway #3 looking north without any controls in place to prevent the blast materials and other pollutants from discharging.

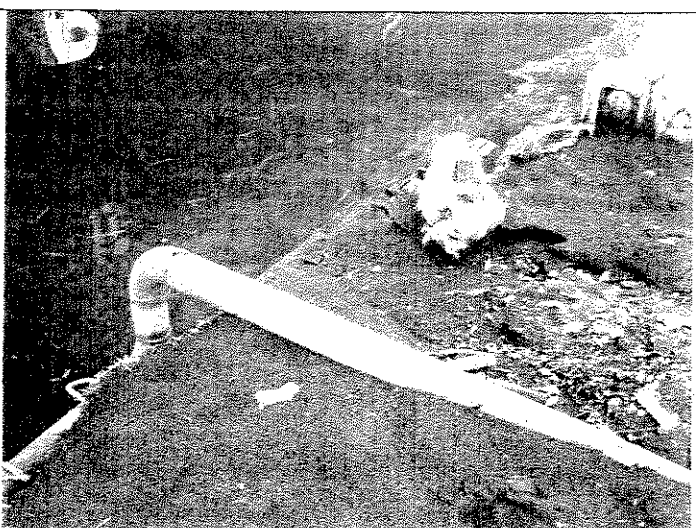
Erosion rill at railway#3. Sandblast grit easily makes it to the water since this is above the lip of the bulkhead.

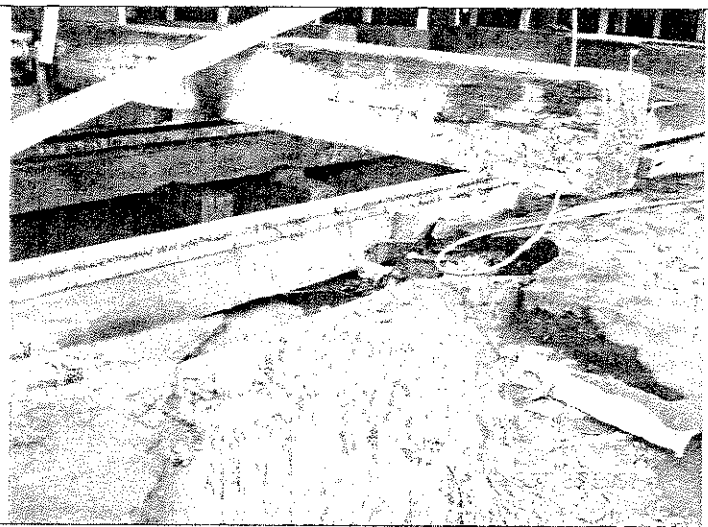
Railway #3 with erosion pattern underneath the railway. Note the depth of the rill.

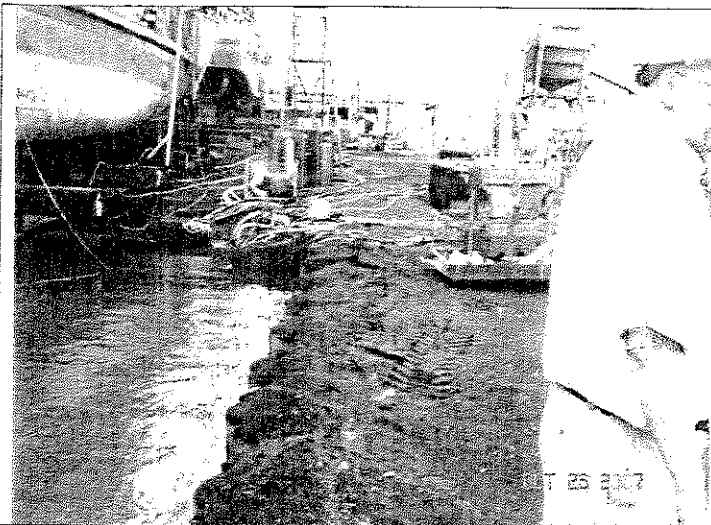
View looking to the north. Note the amount of sandblast grit piles up at the bulkhead area. This material can be discharged to the water with wind or rainfall.

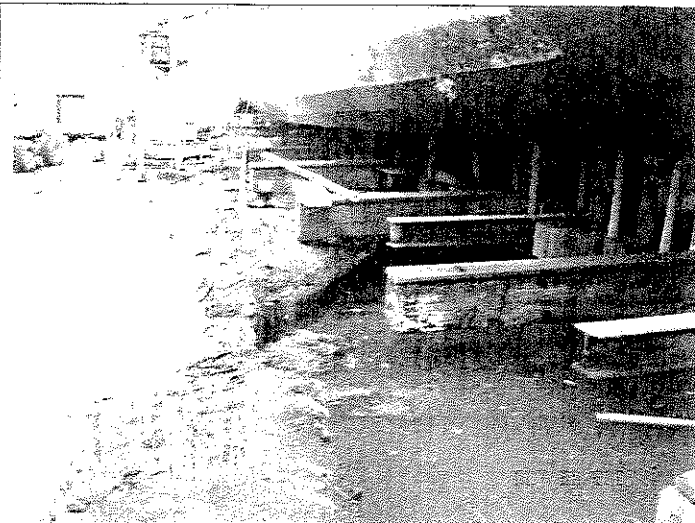
North view on railway #2. No controls are in place to prevent the loss of the sandblast grit.

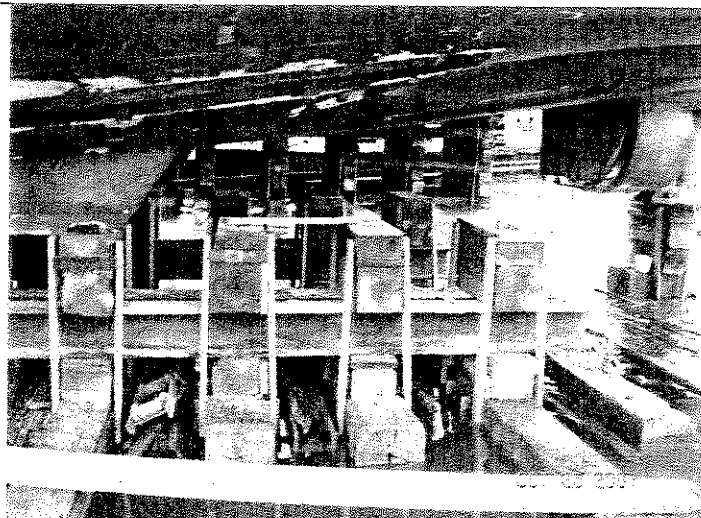
Work over the water that deposited material on the cross beams. Unknown if steps were taken to prevent this material from falling in to the water.

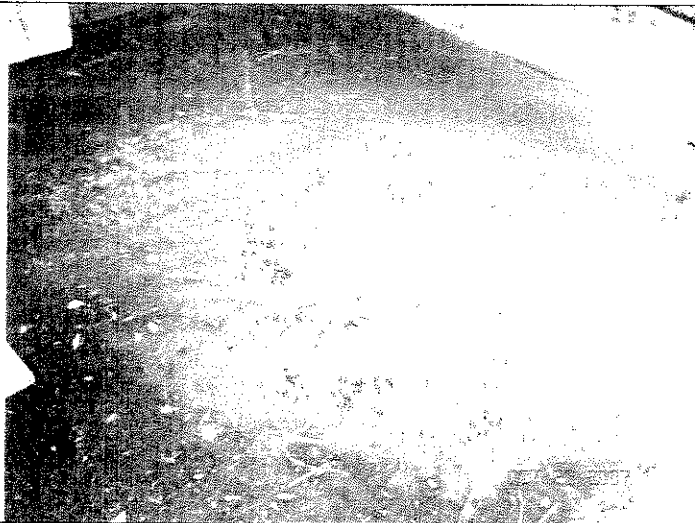
Sandblast grit and welding rods in the water.

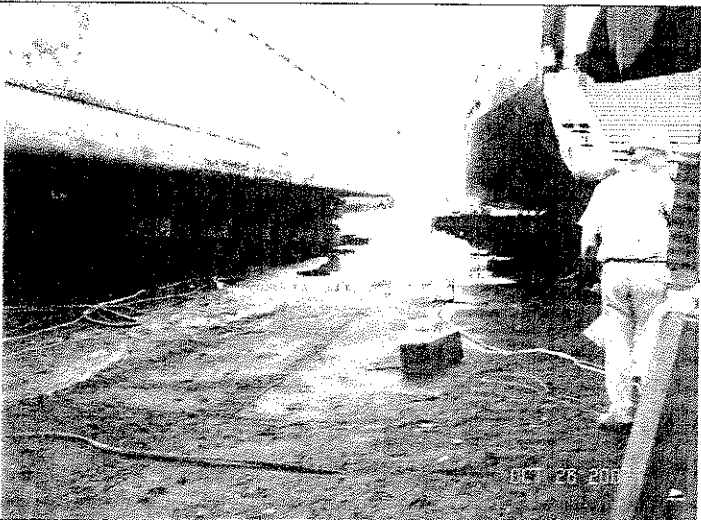
Area between railways #2, on the right and #1. All of this area is covered with sandblast grit from the head of the railways to the water. No controls are in place to prevent pollutant discharges.

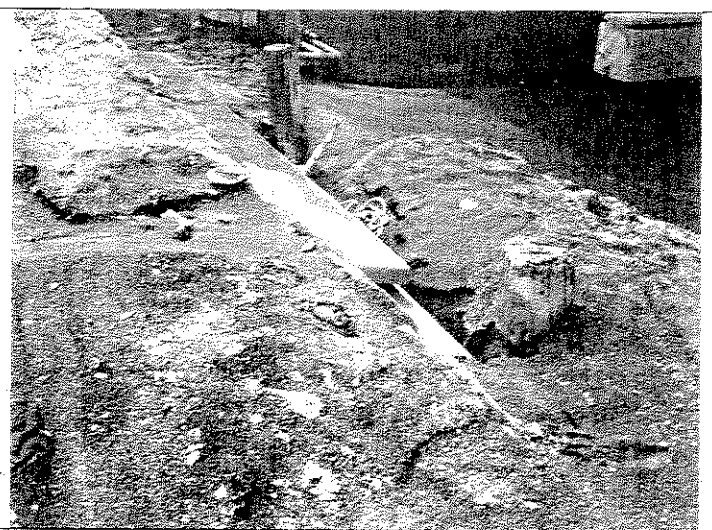
Paint and debris in the sandblast material at railway #1 near the waterfront. Note the erosion patterns going towards the water.

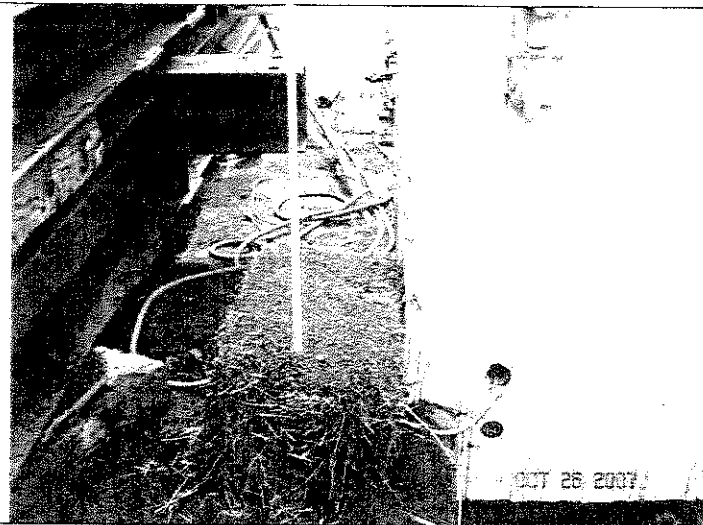
This area can be seen in the photo above and is to the left of the small building at the pier. The fact that the sandblast grit is making it to this location provides indications of little or no control in keeping the sandblast material near the areas of use.

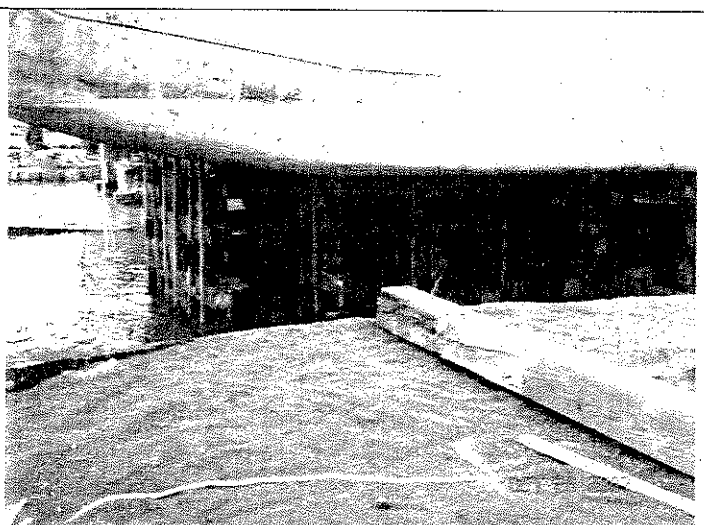
Railway #1 with sandblast overtopping the bulkhead.

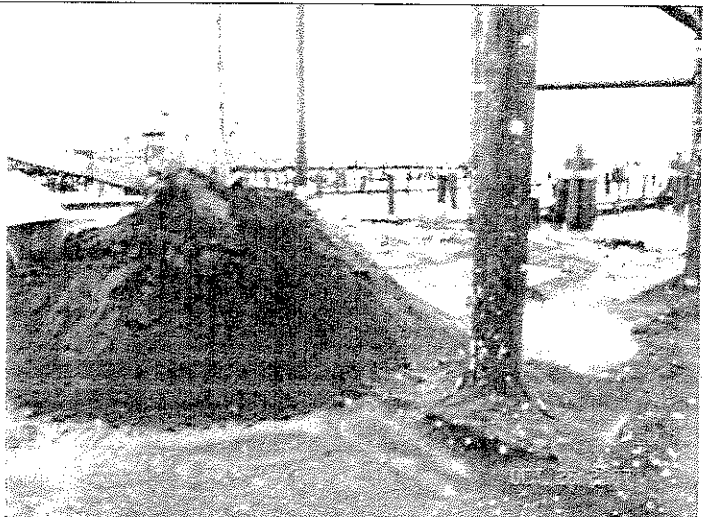
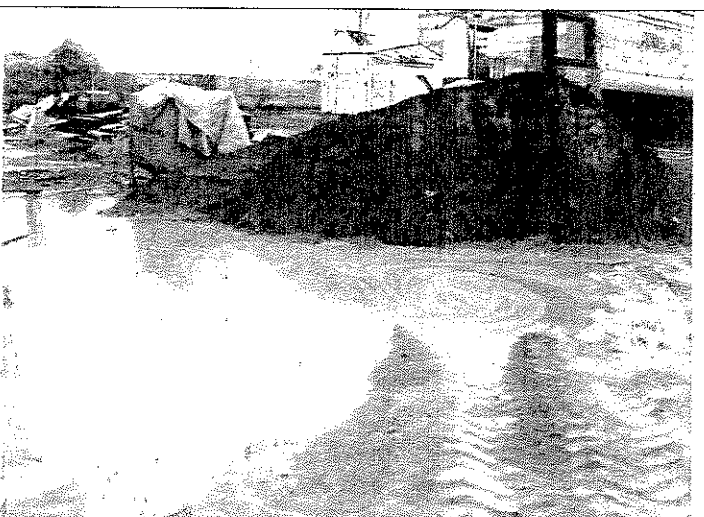
The photo on the left shows the pile of grit between railways #3 and #2. During the site visit a front end loader was observed piling material on the the pile. It appeared to be coming from the pile shown on the right, located at the head of railway #2. Facility personnel could not explain why this material was being moved to the water front verses a location for transport off site.

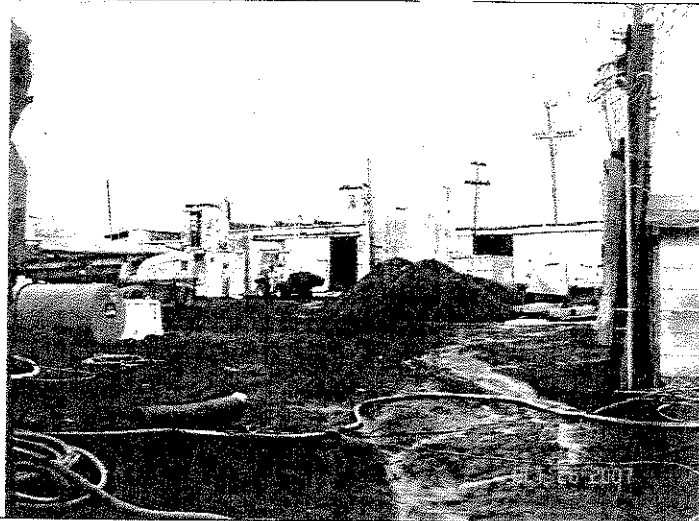
Same pile of grit at the head of the railway #2.

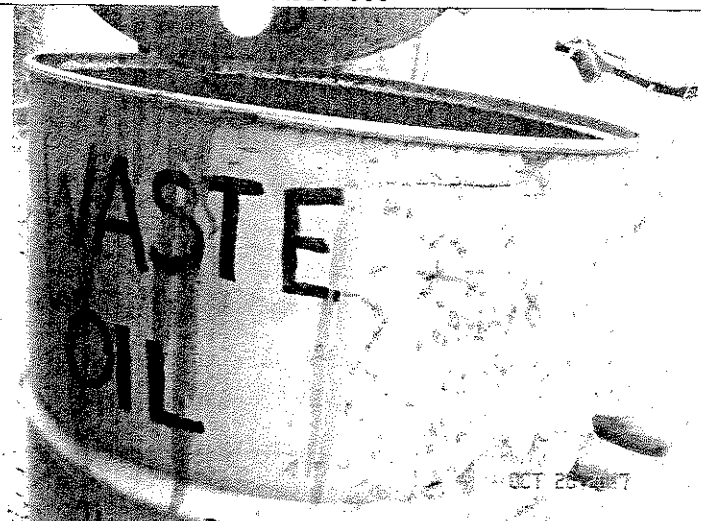
Drum marked waste oil though a strong solvent smell was assessed when the lid was lifted.

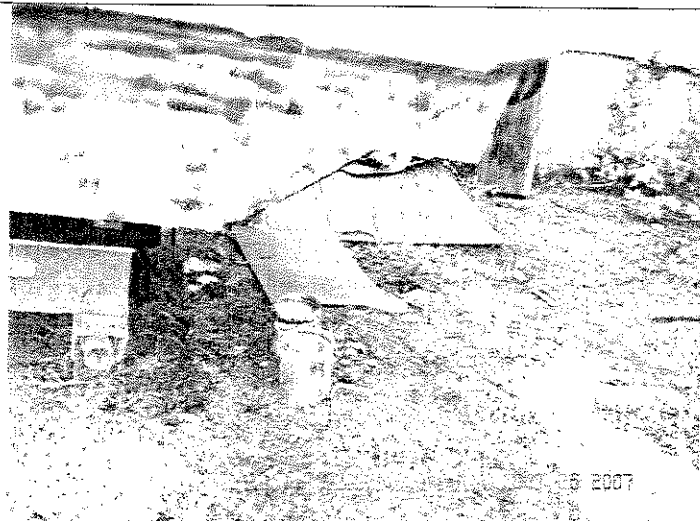
Open containers filled with water. This is just one example that was observed in several locations.

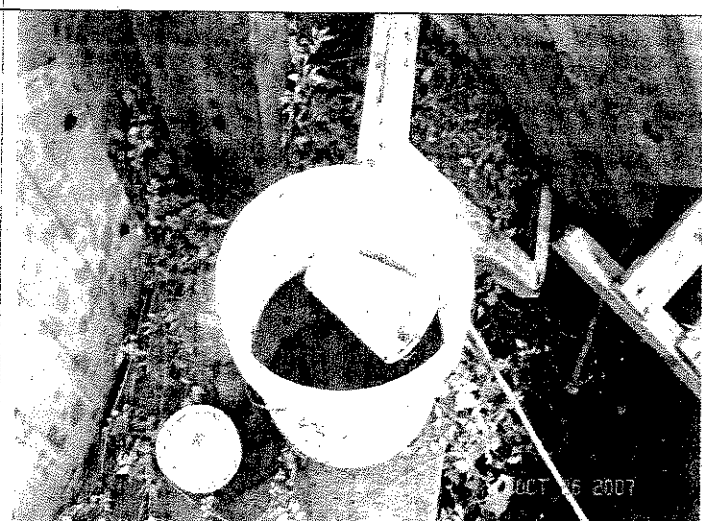
This bucket was observed in the exact same location during the September site visit.

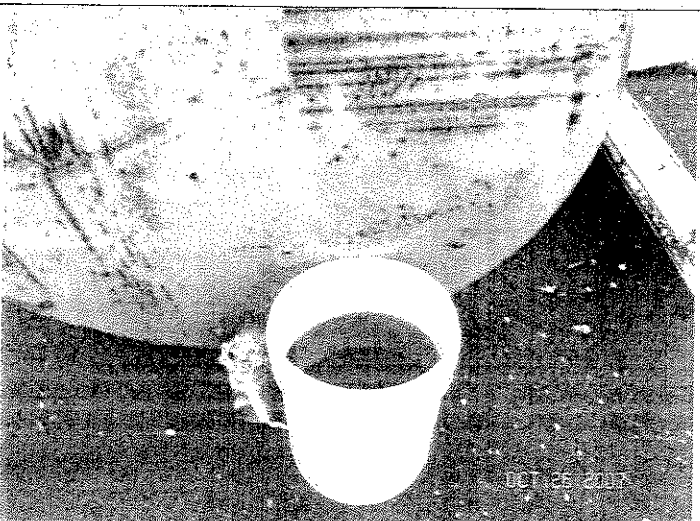
Open container of what appears to be petroleum based liquid. A lead/acid battery was also found near this location.

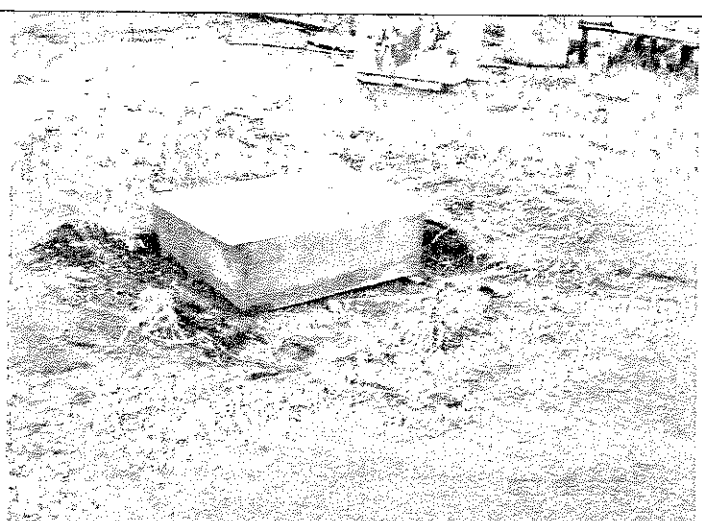
Stormwater discharge point that is not permitted. This has been an issue over several site visits with facility personnel reporting that the discharge has been prevented. The erosion patterns seen do not support this statement.

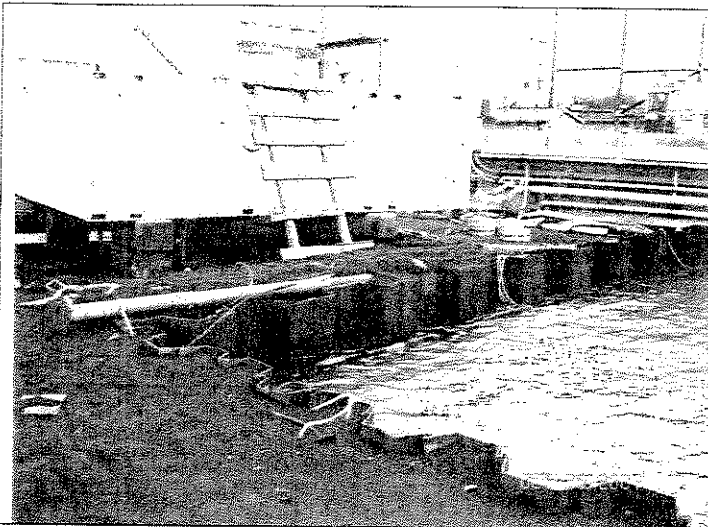
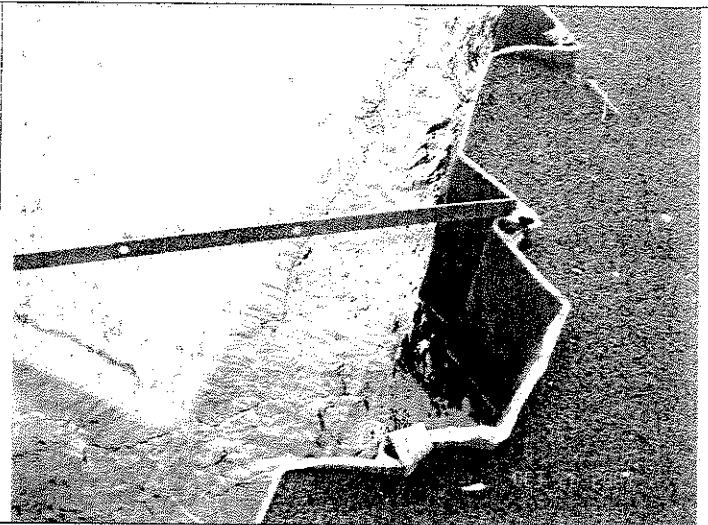
Work area adjacent to both the covered shops and the concrete service pier. One of the shops can be seen in the photo below. It appears that sandblasting had recently been conducted with these tanks just recently painted. Without any controls in place, it appears that the blast material is leaving this work area and being deposited at several locations, including the river. The right photo shows the cross beam for the bulkhead covered in sandblast material. Several areas of the bulkhead have blast grit overtopping the lip.

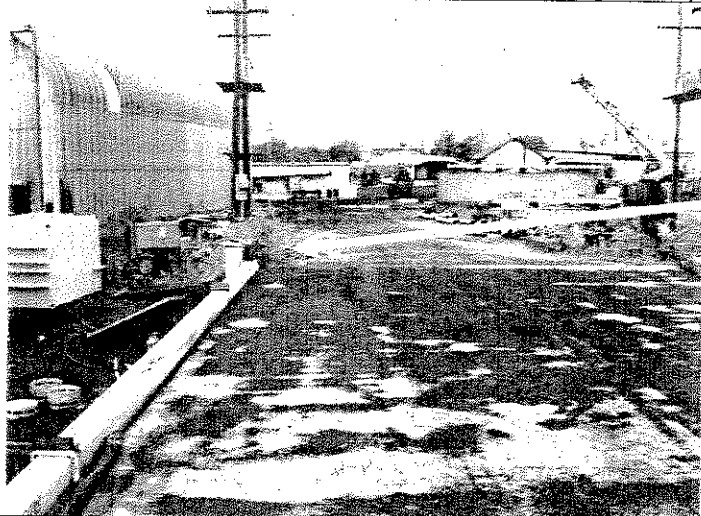
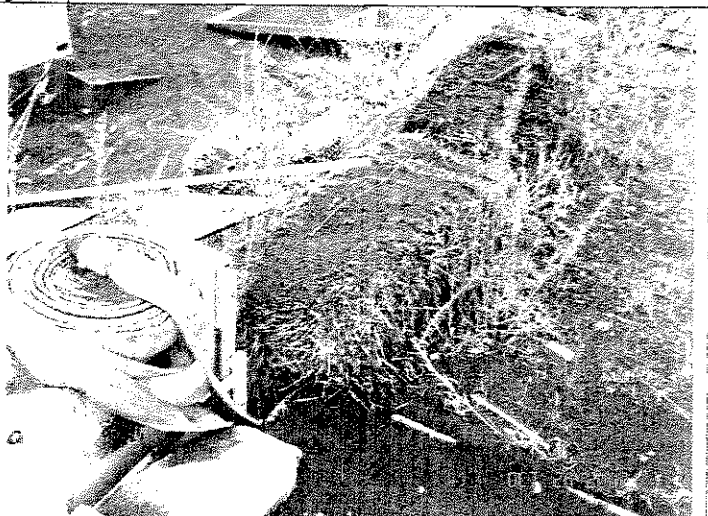
The shop can be seen in the left background. The work area is located in front of this shop. The hay bales shown in the photo on the right are located at the end of the pier, indicated by the arrow. Deposition of the blast materials on the bales also provides indications that the blast material is making it to and covering the pier.

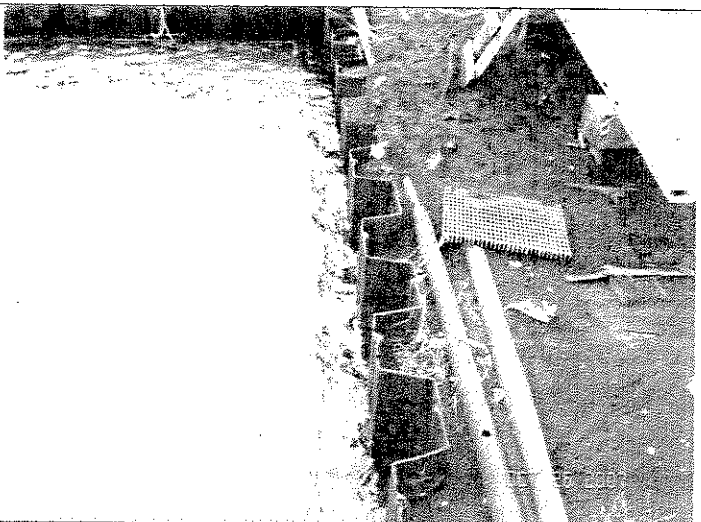
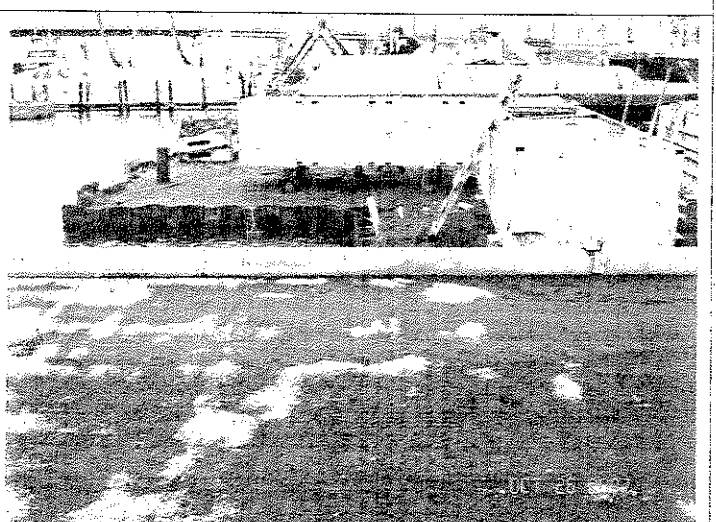
Close up of the work area that is also shown in the right photo. The right photo shows that if this blast material is being deposited onto the pier, then material is also being deposited in to the water.
